1966 Chevy Impala

A FIRE-WRECK TO AWARD WINNER

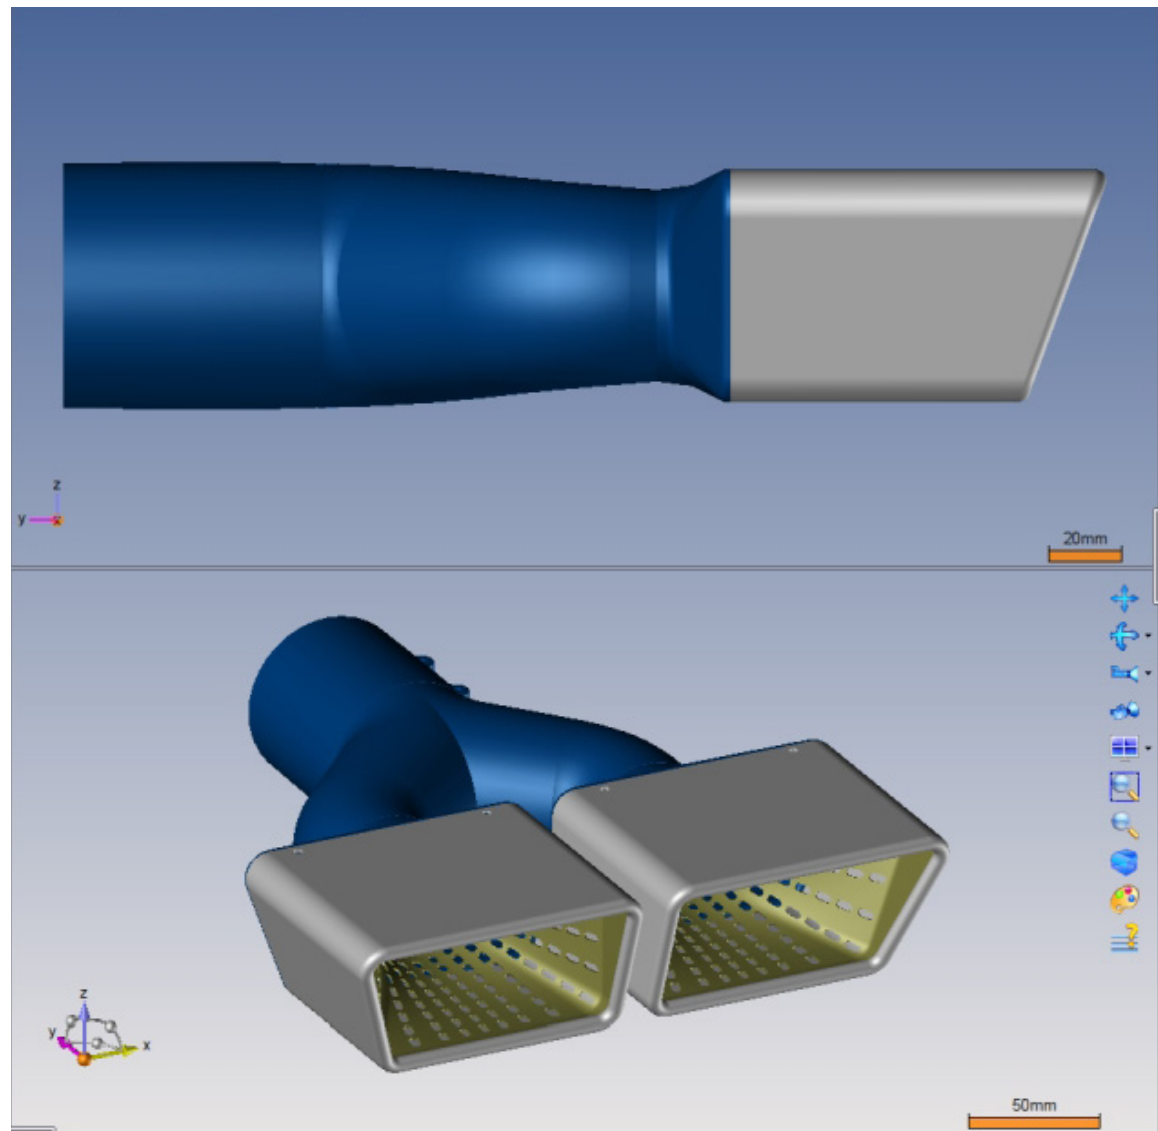
Initial TopSolid designs for the custom tailpipes.

classic feel of the car, while adding a modern flair. He began considering different designs and testing a few models. The design he landed on has rectangular tailpipes, with the outer sides and rear edges angled, mimicking the Impala's rear bumper. He then designed the 3D models in a software program called [TopSolid](#). They became the basis for the metal parts later 3D printed in the XM200C.

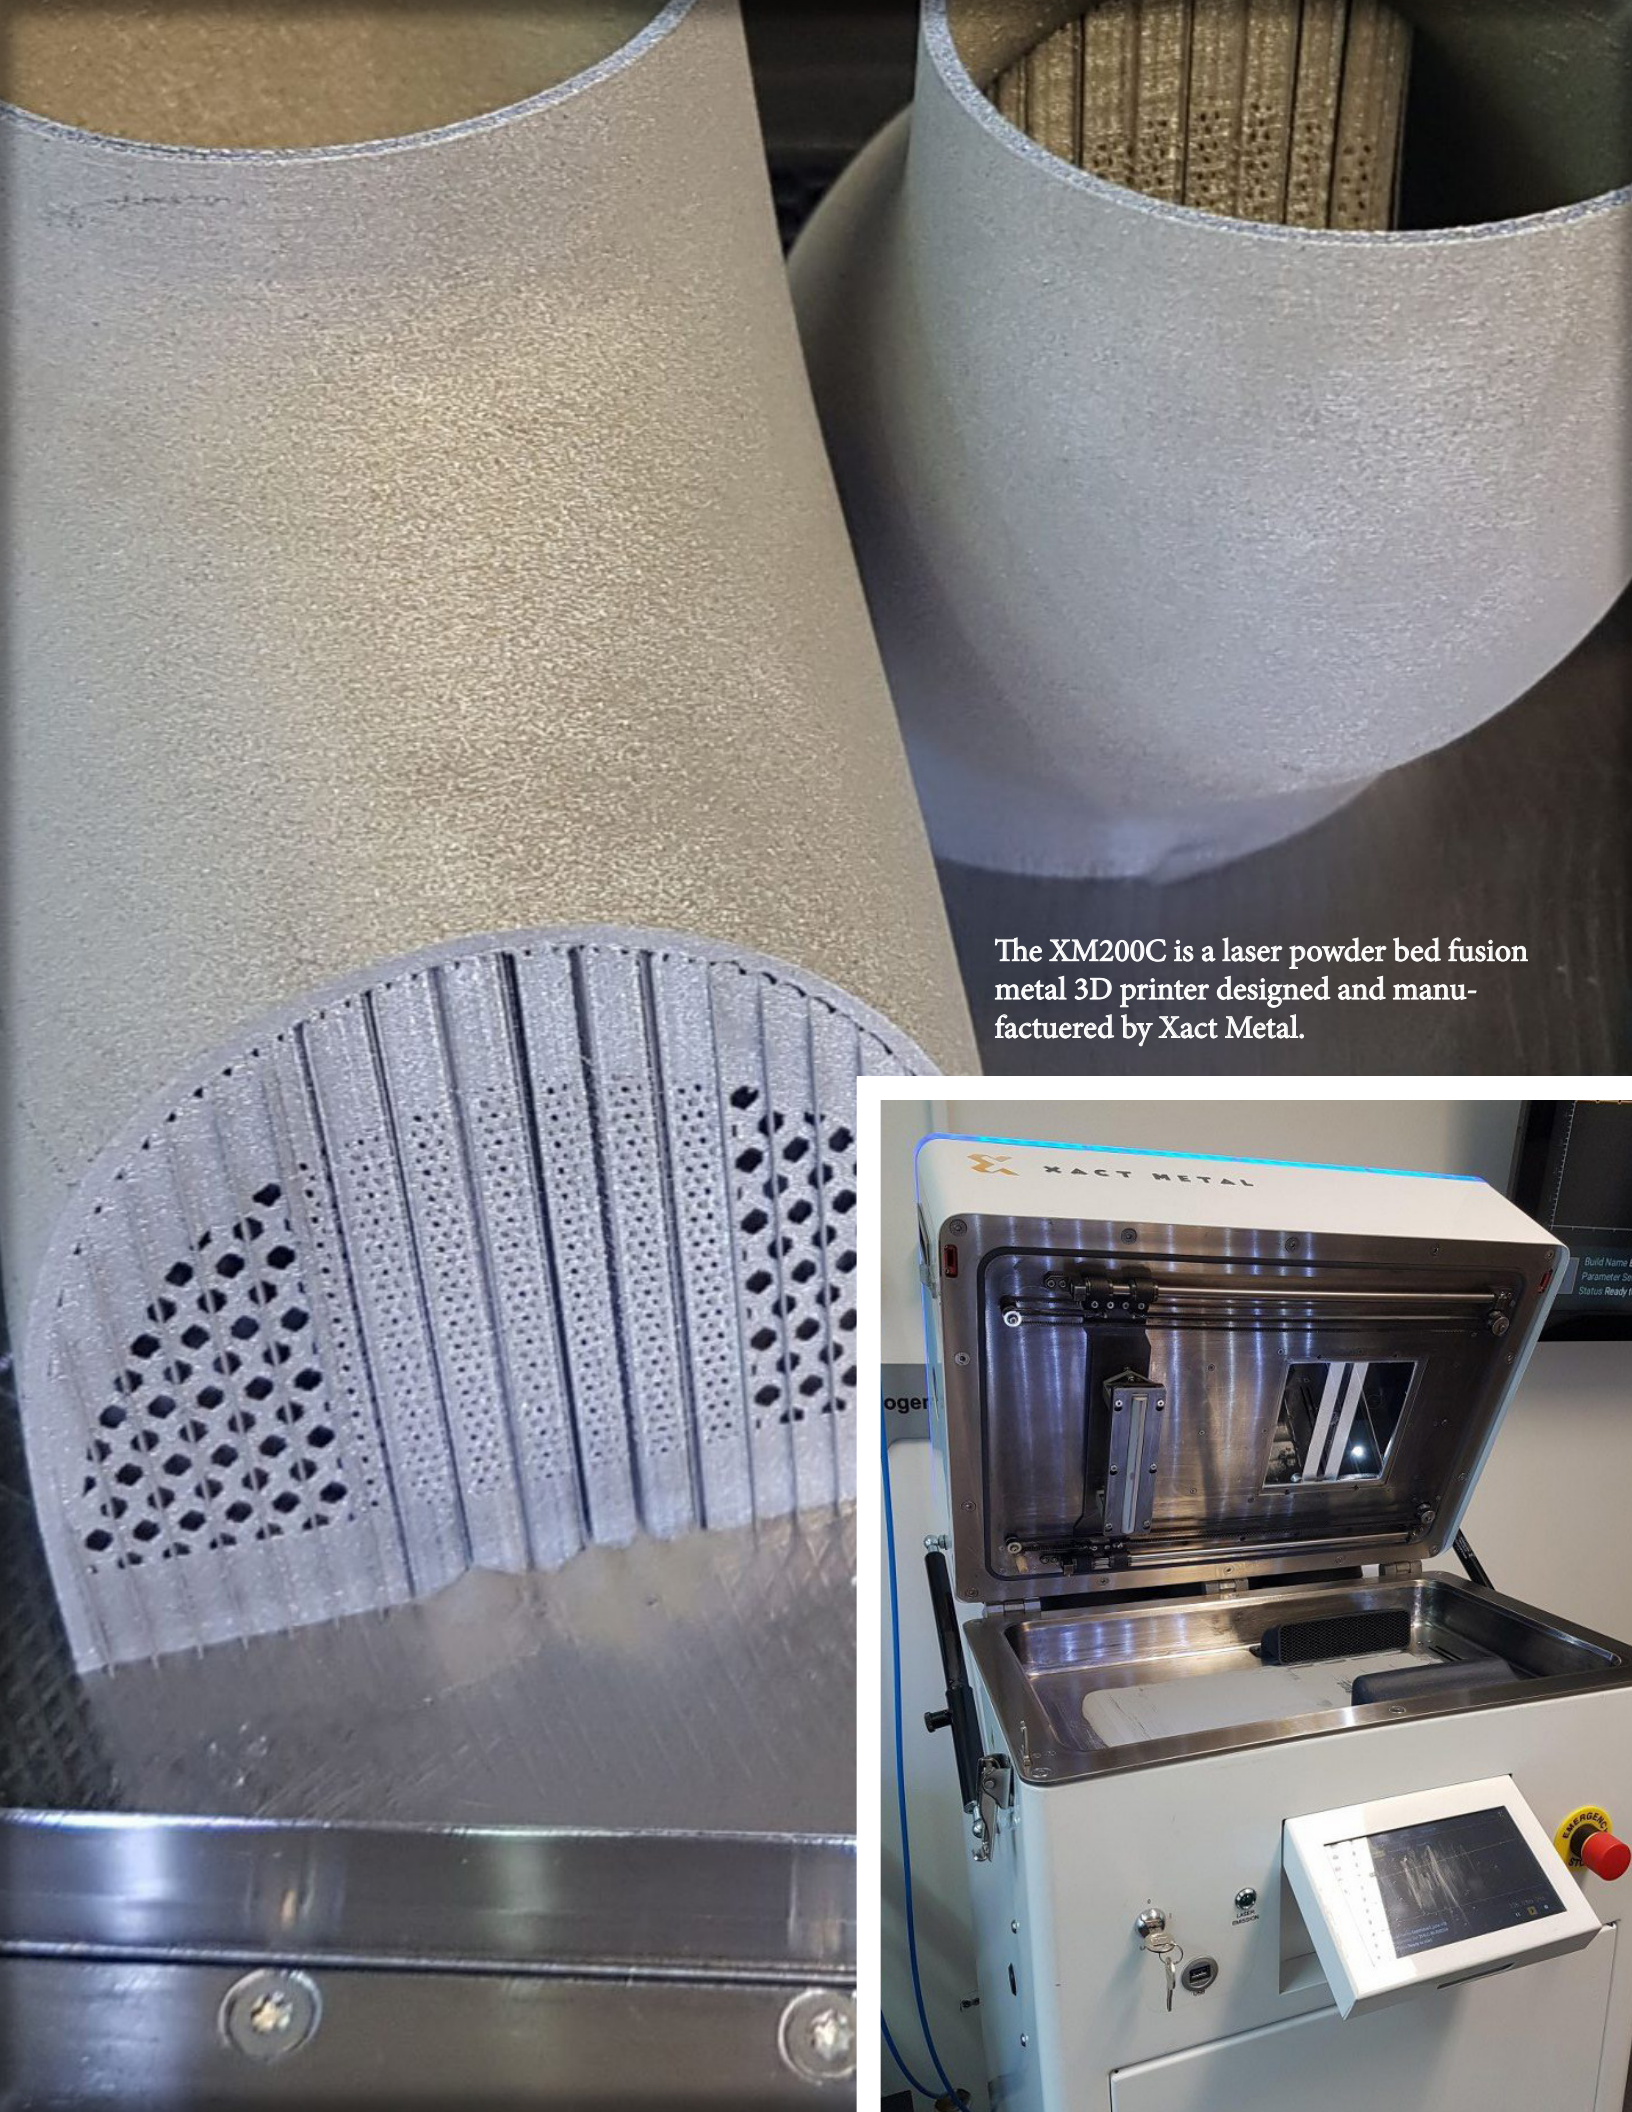
The XM200C is a laser powder bed fusion metal 3D printer designed and manufactured by Xact Metal.

In the XM200C, parts are built upwards using a high energy laser that traces a geometry in a metal powder, layer by layer, to form the part. When the part is complete, the geometries are welded directly to the plate. The excess powder is removed and recycled, the part is cut off the plate and the support material is removed. This can be done by hand using pliers. These parts could be functional directly after printing, as they are fully dense as-printed. However, in the interest of aesthetics, all parts except the inserts, are sanded and polished. Specifically the end pipe, which is the most visible component.
